**BAGHDAD POLICE COLLEGE  
BAGHDAD, IRAQ**

**SIGIR PA-06-078.2**

**SIGIR PA-06-079.2**

SUBJECT: Report on Project Assessments of Reconstruction Work Performed Under Task Orders 06 and 29 at the Baghdad Police College, Baghdad, Iraq (Report Numbers SIGIR PA-06-078.2 and PA-06-079.2)

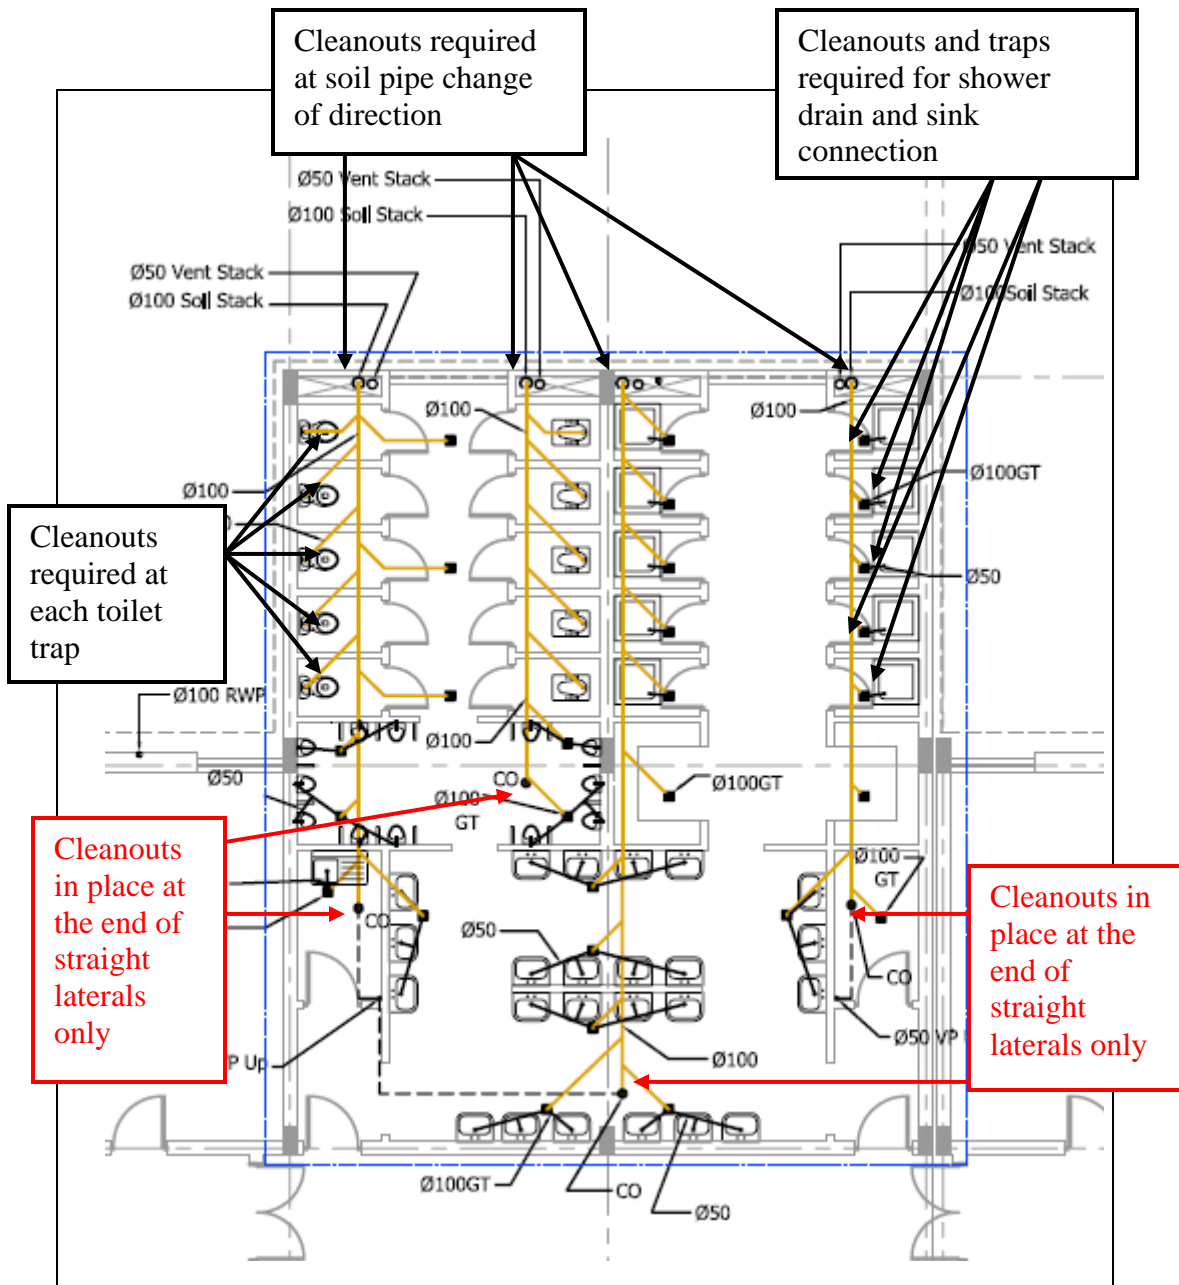
Figure 2. Floor plan and soil pipe detail for a typical cadet barracks facility

The as-built drawings for the cadet barracks indicate cleanouts were only used at the far end of a straight run of soil pipe, not for every toilet trap and change of direction (Figure 2). The government engineers reviewing the cadet barracks design drawings failed to detect and identify the lack of a sufficient number of cleanouts and traps at the correct locations. As a result, not only did the contractor not follow the specific code requirement, which is compounded by the contractor's poor plumbing installation and construction, but the likelihood of the sewer lines backing up increased significantly, even under normal use.

1. Require the contractor to replace all existing plumbing fixtures and fittings in all newly constructed buildings to comply with the International Plumbing Code in accordance with contract specifications. Specifically, eliminate the use of cemented joints, abnormal fittings, and improperly sealed pipe connections. In addition, require the use of cleanouts, traps, and proper sealing techniques.

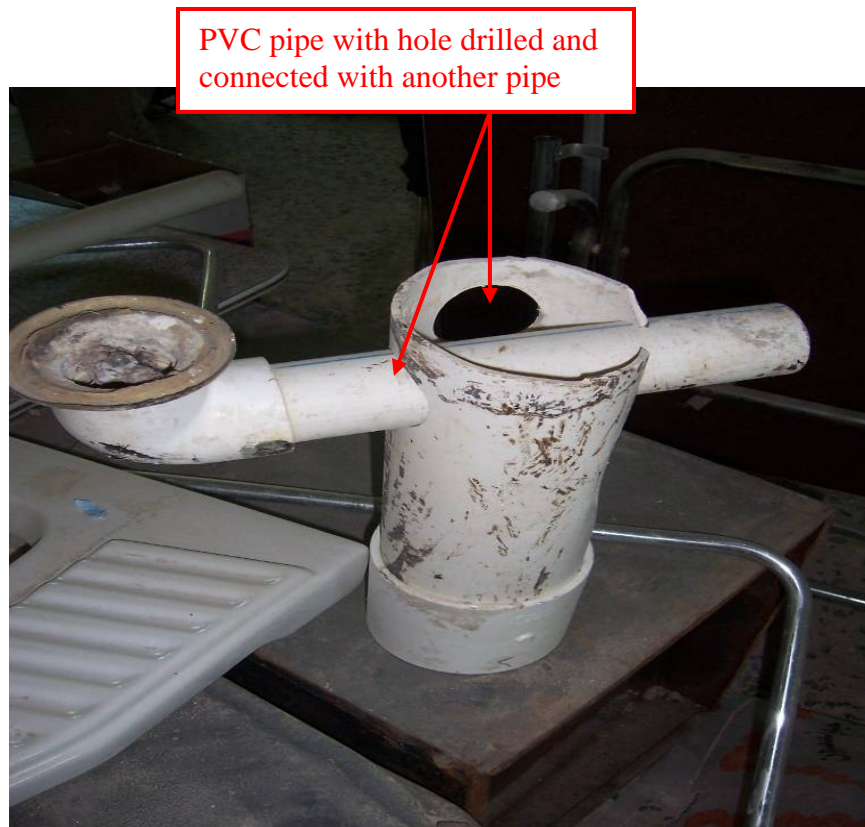
**Site Photo 3. Typical cadet barracks plumbing fixture**

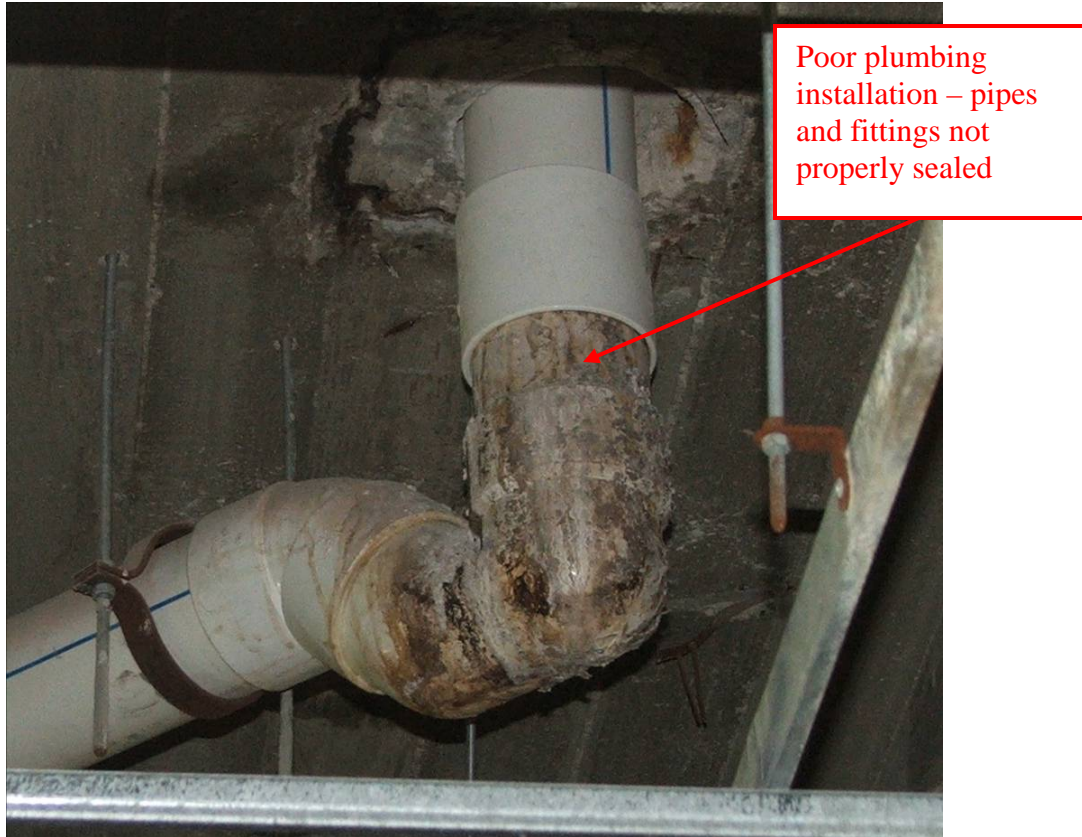
**Site Photo 4. Improper pipe sealing in cadet barracks**

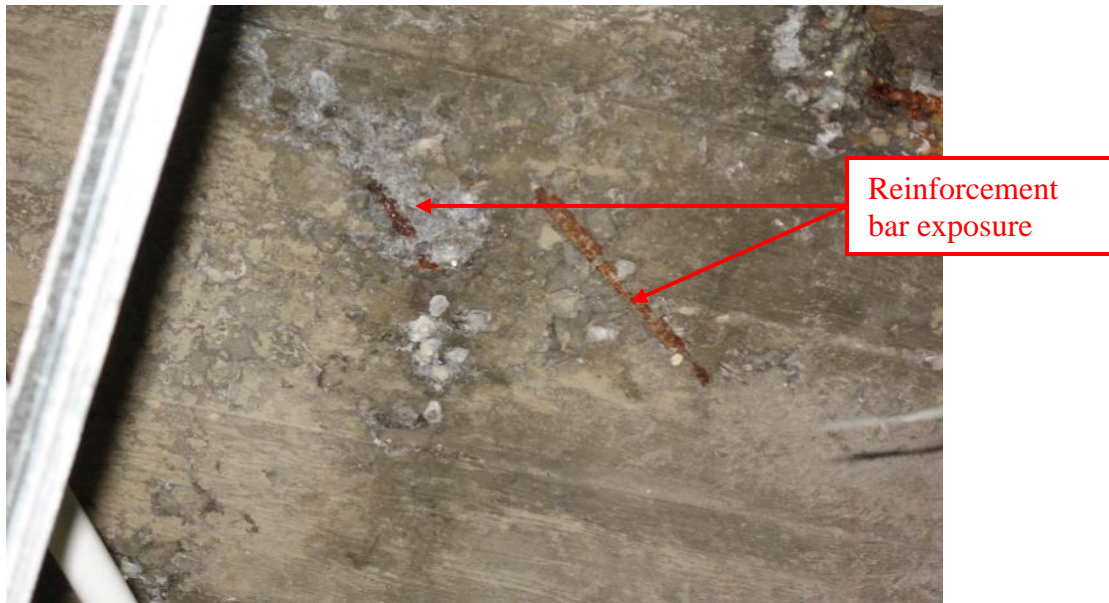
**Site Photo 5. Reinforcement bar exposure in cadet barracks**

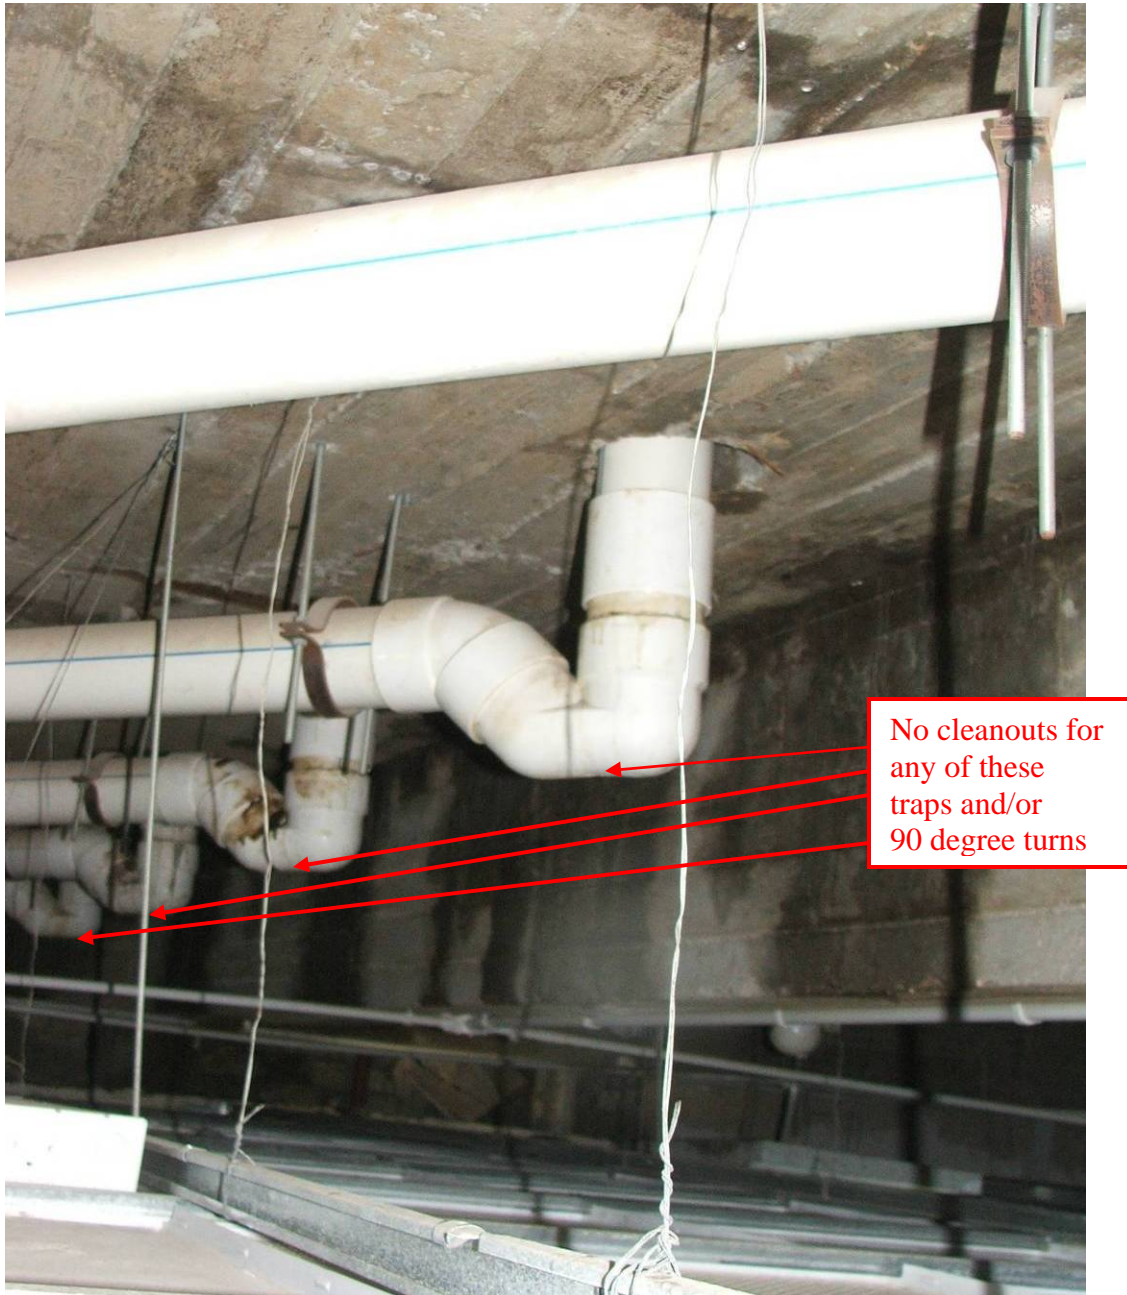
No cleanouts for  
any of these  
traps and/or  
90 degree turns

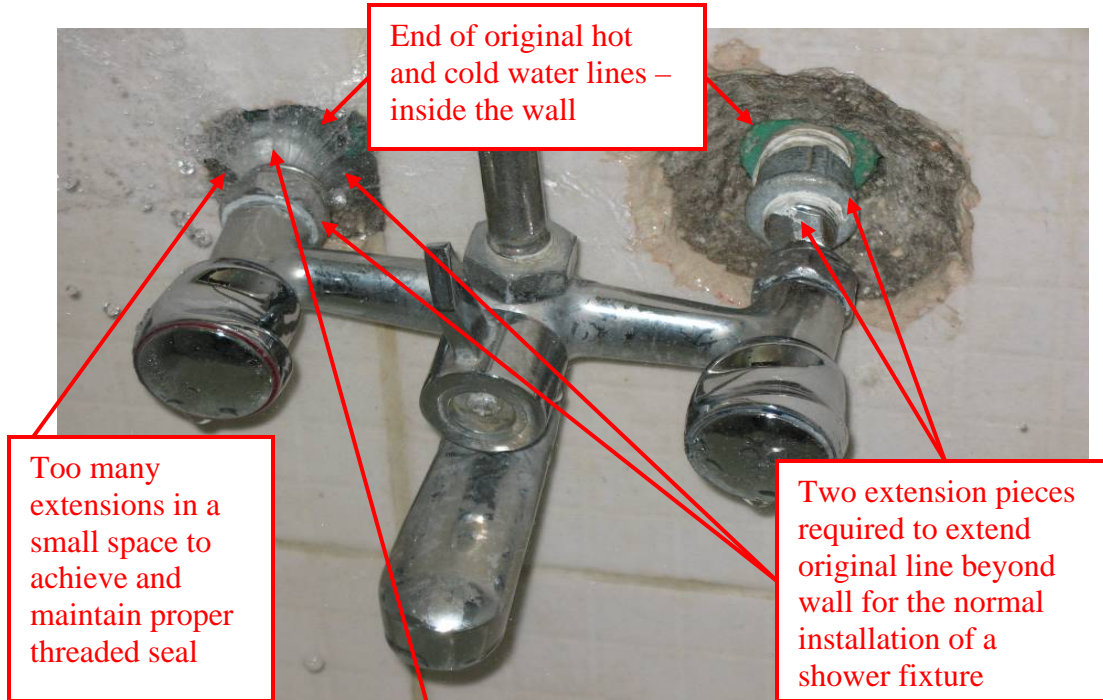
the ground floor (Site Photo 12). A third floor plumbing fixture was leaking and apparently was not correctly installed and sealed to the wall, which consequently allowed water to flow down to the ground floor.

Site Photo 11. Leaking shower fixture in cadet barracks

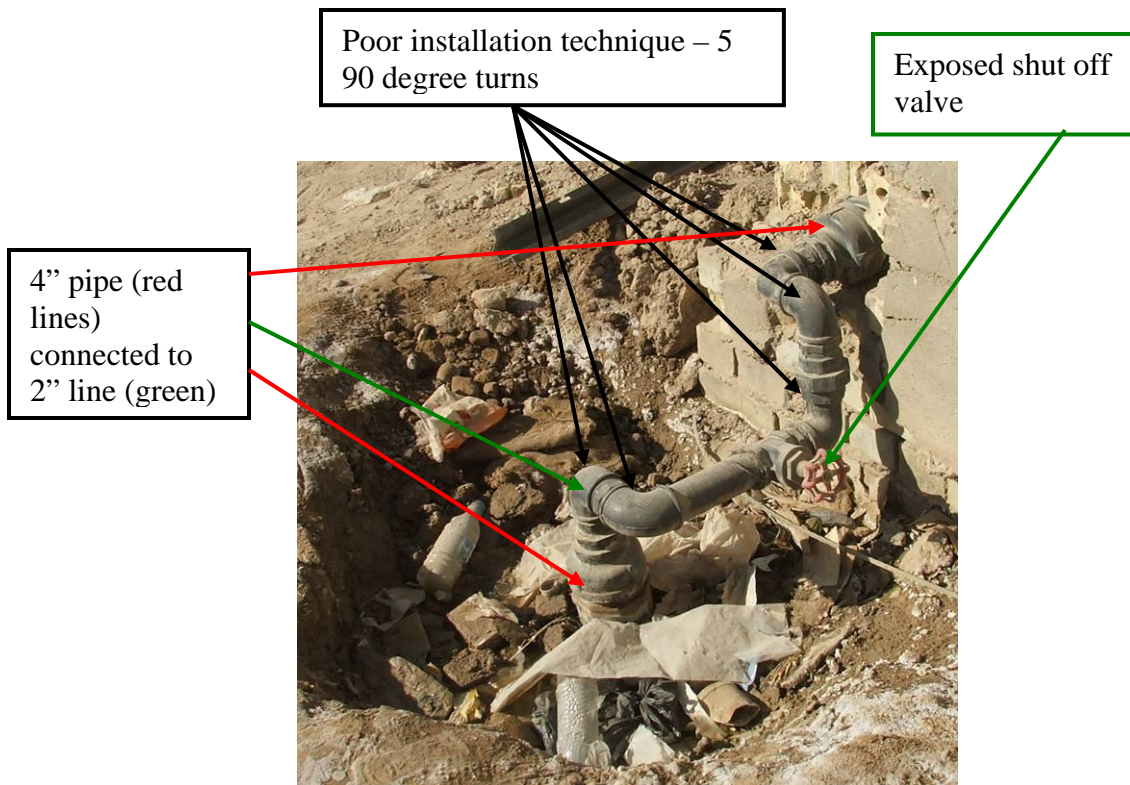
**Site Photo 13. Installed main water line to instructors' barracks**

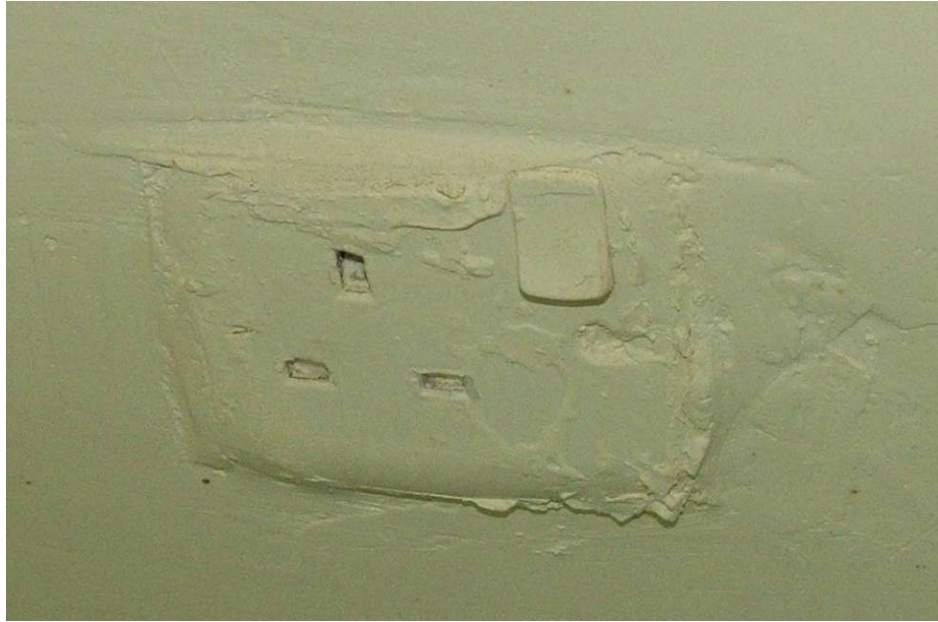
**Site Photo 16. Unusable electrical outlet - mortar and paint inside the outlet**

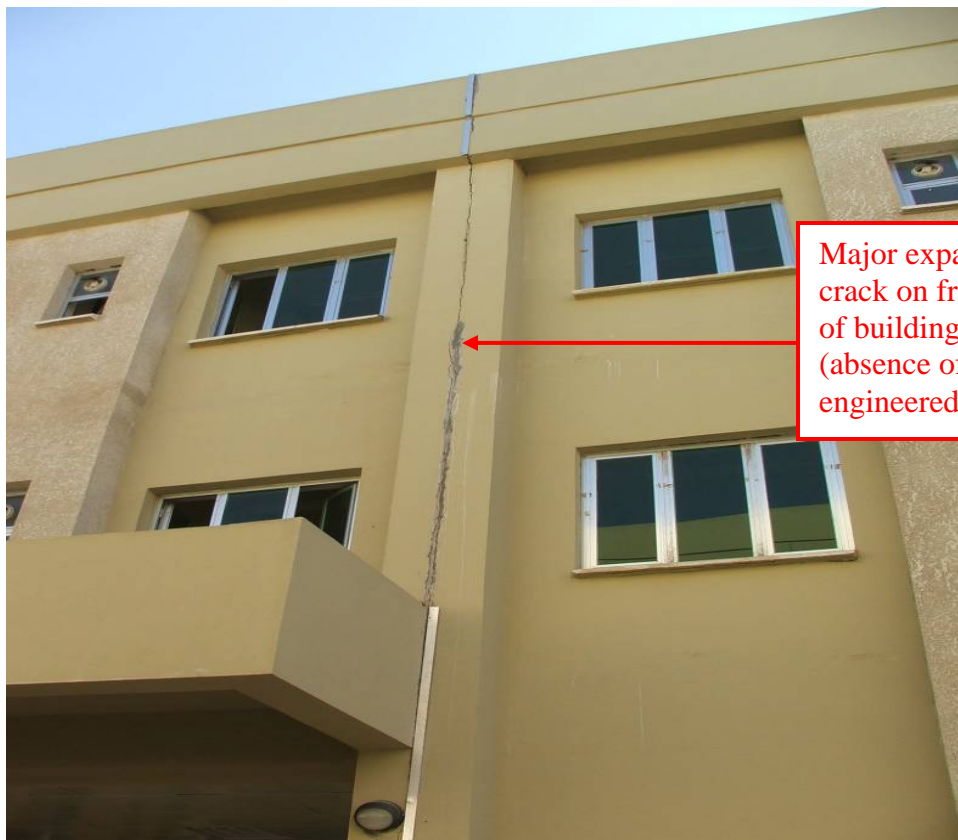
More importantly, we discovered significant expansion cracks on the exterior and interior of the buildings (Site Photos 17-20). We determined that the contractor's as-built drawings (Figure 4) do not reflect the reality of what was actually constructed at the instructors' barracks.

**Site Photo 17. Exterior expansion crack on the instructors' barracks**

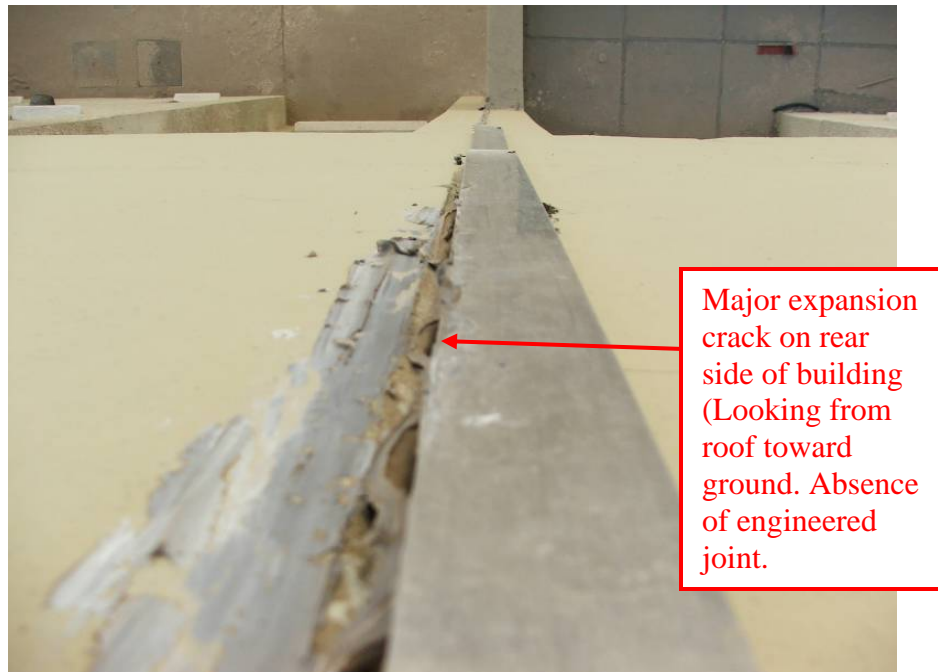
**Site Photo 18. Exterior expansion crack on rear side of instructors' barracks**

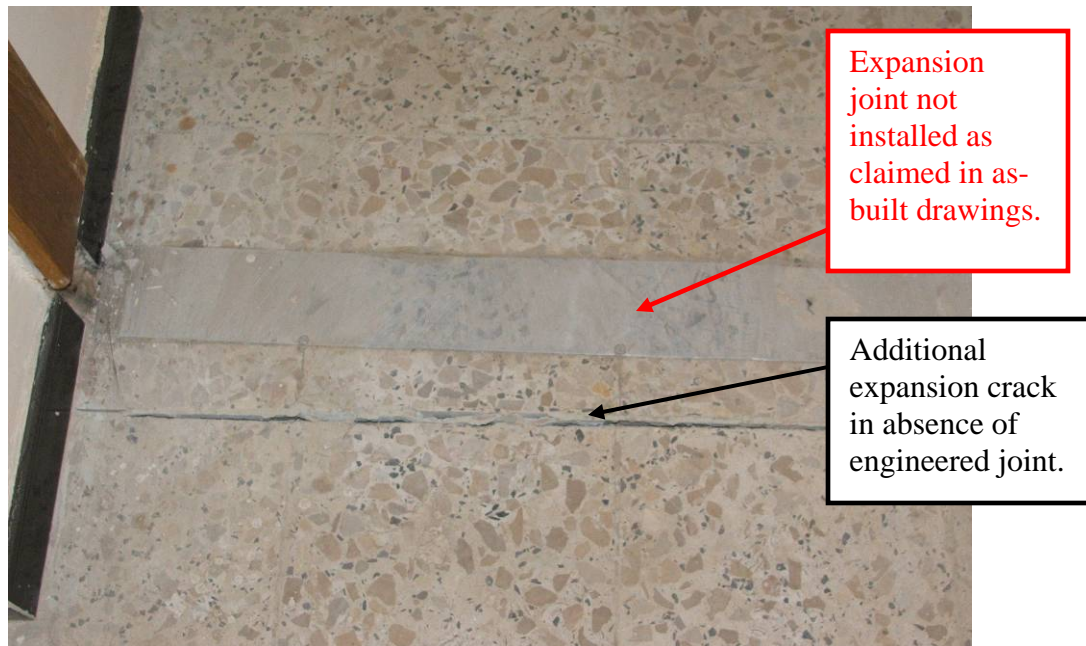
**Site Photo 19. Interior expansion crack in instructors' barracks**

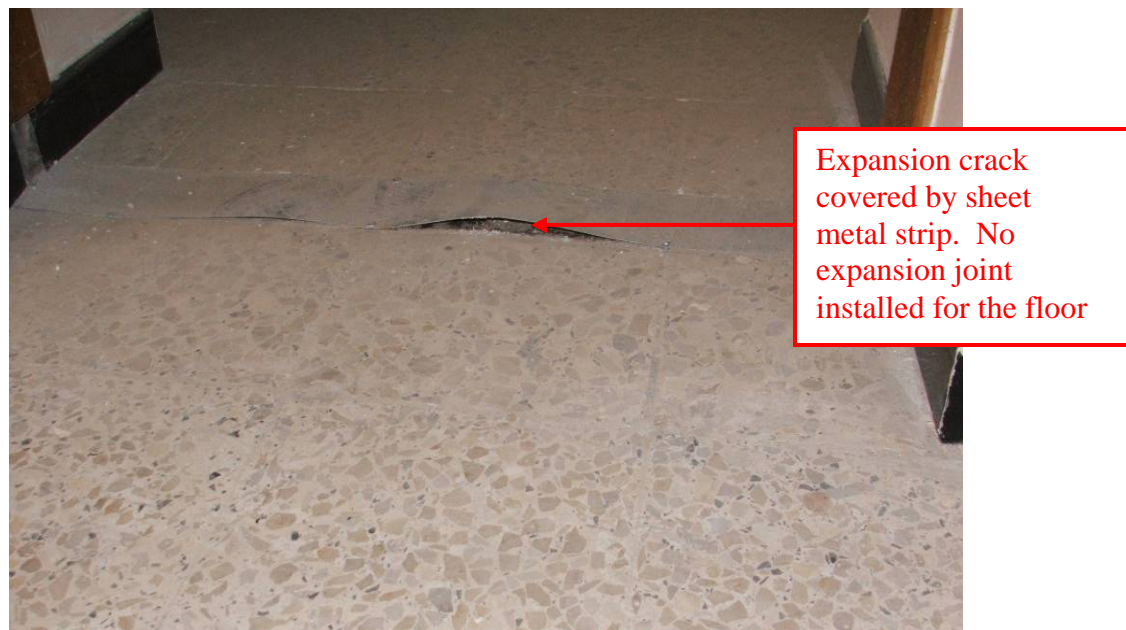
**Site Photo 20. Interior expansion crack inside the instructors' barracks**

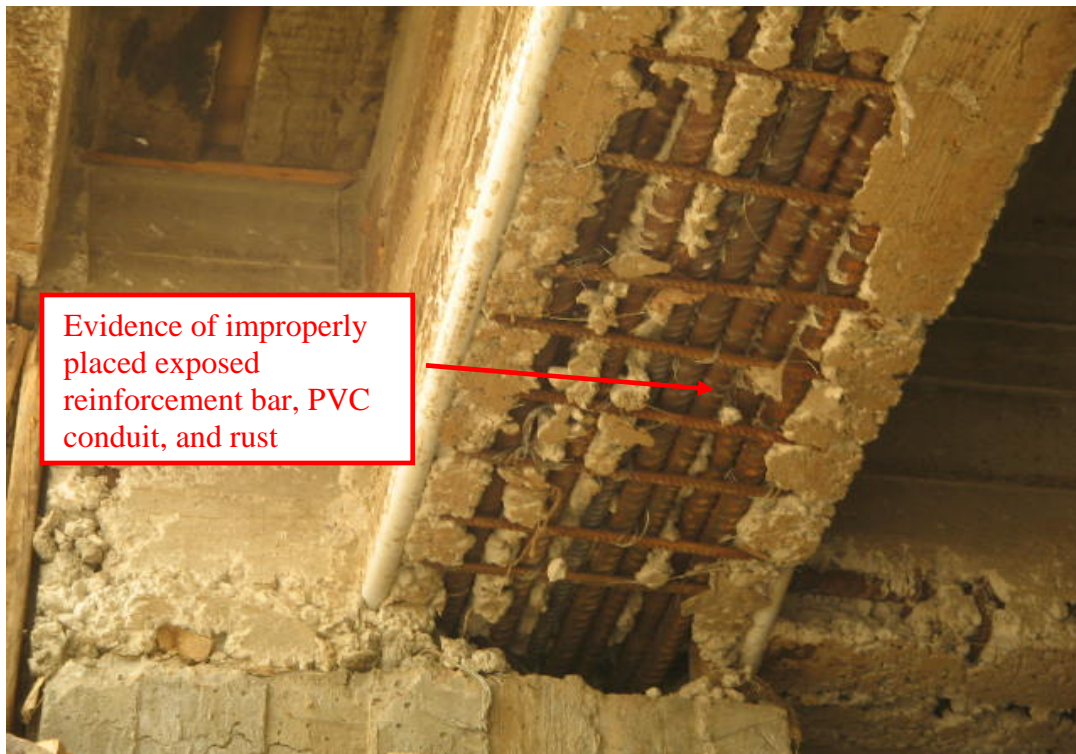
**Site Photo 21. Evidence of improperly placed exposed reinforcement bar, PVC conduit, and rust**

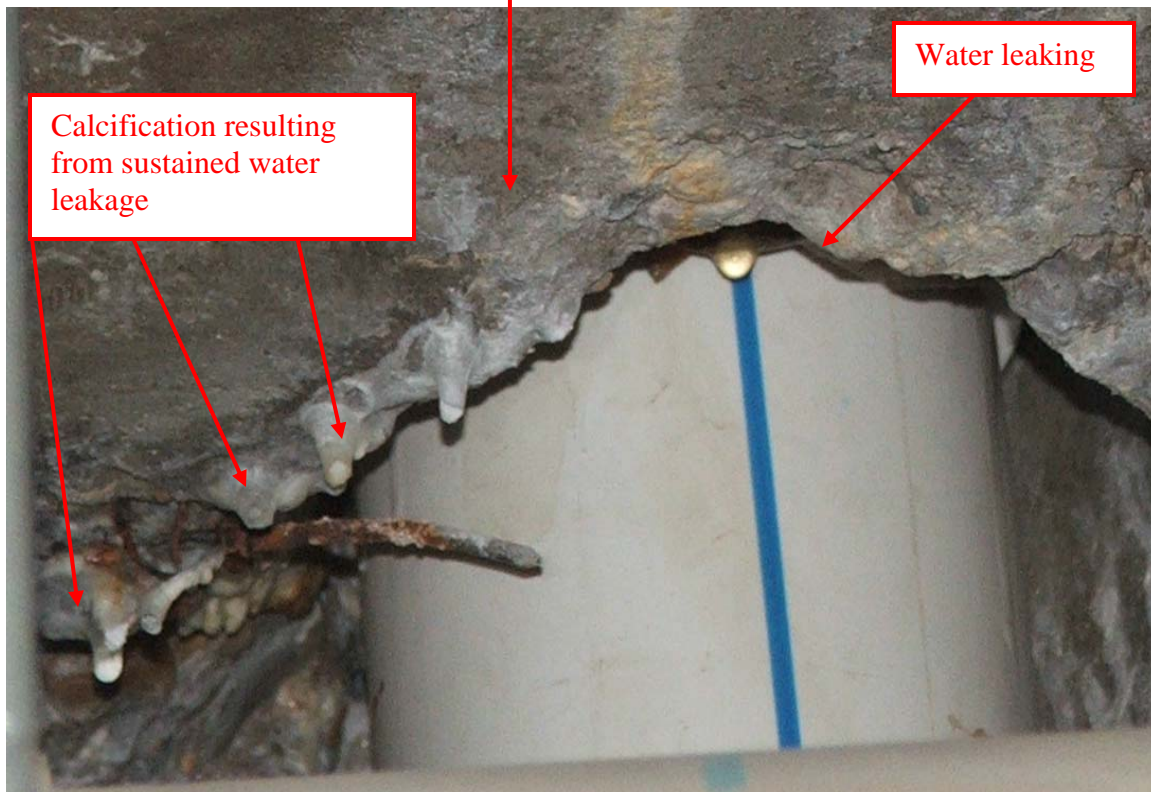
**Site Photo 42. Enlarged view of Site Photo 41**

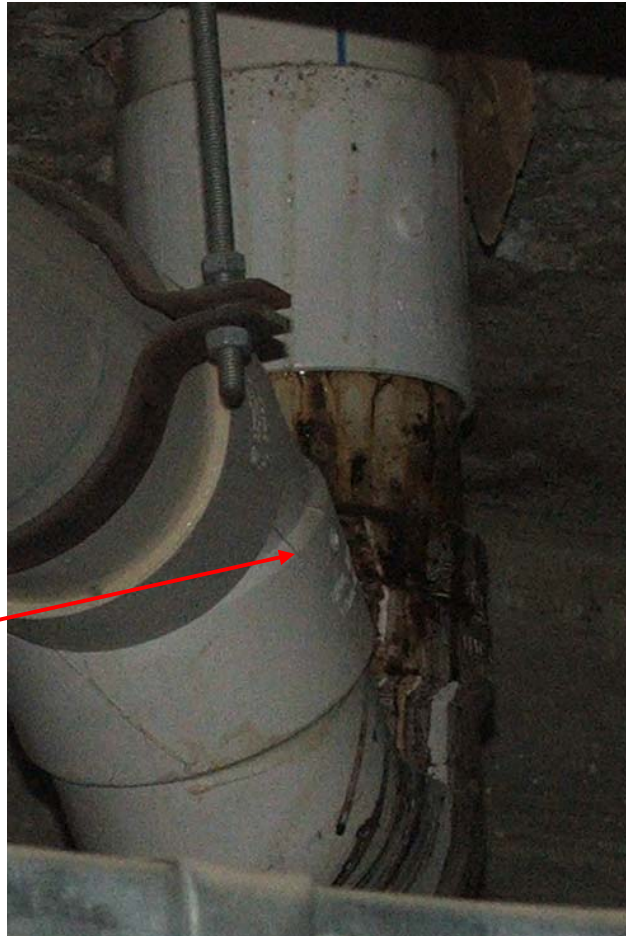
Site Photo 44. Enlarged view of Site Photo 43

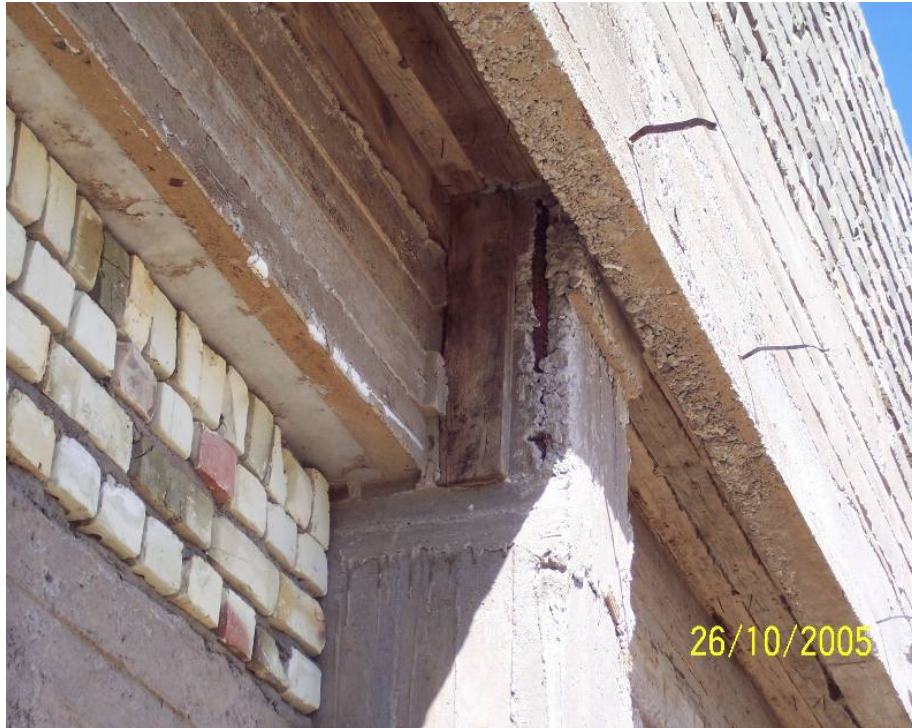
**Site Photo 46. Concrete segregation and exposed reinforcement bar  
(Photo courtesy of the USACE)**

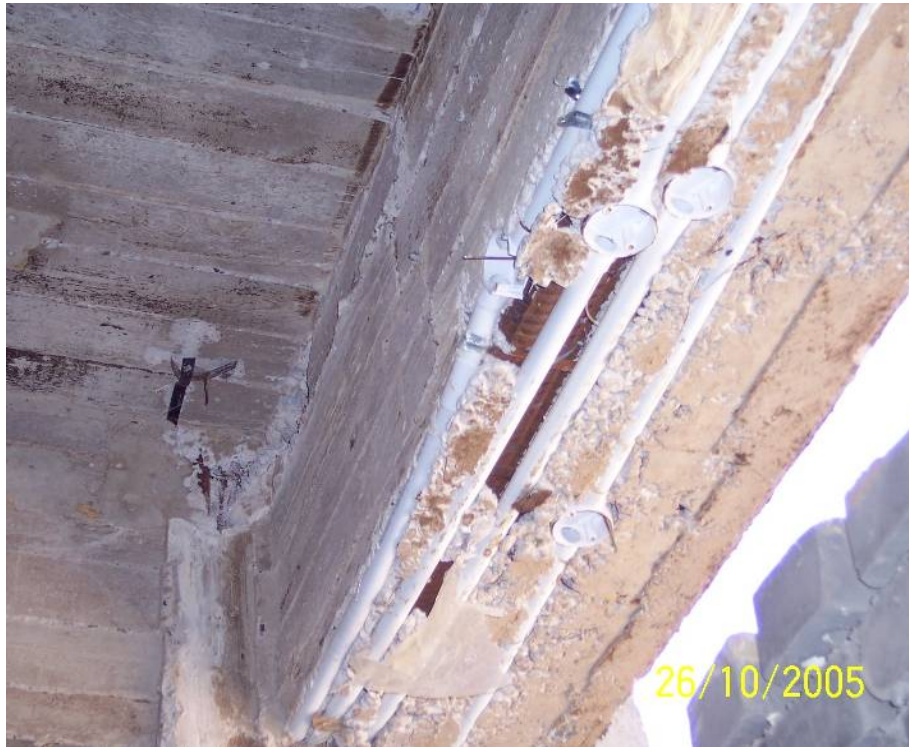
**Site Photo 48. Electrical conduit exposure and reinforcement bar rust**  
(Photo courtesy of the USACE)

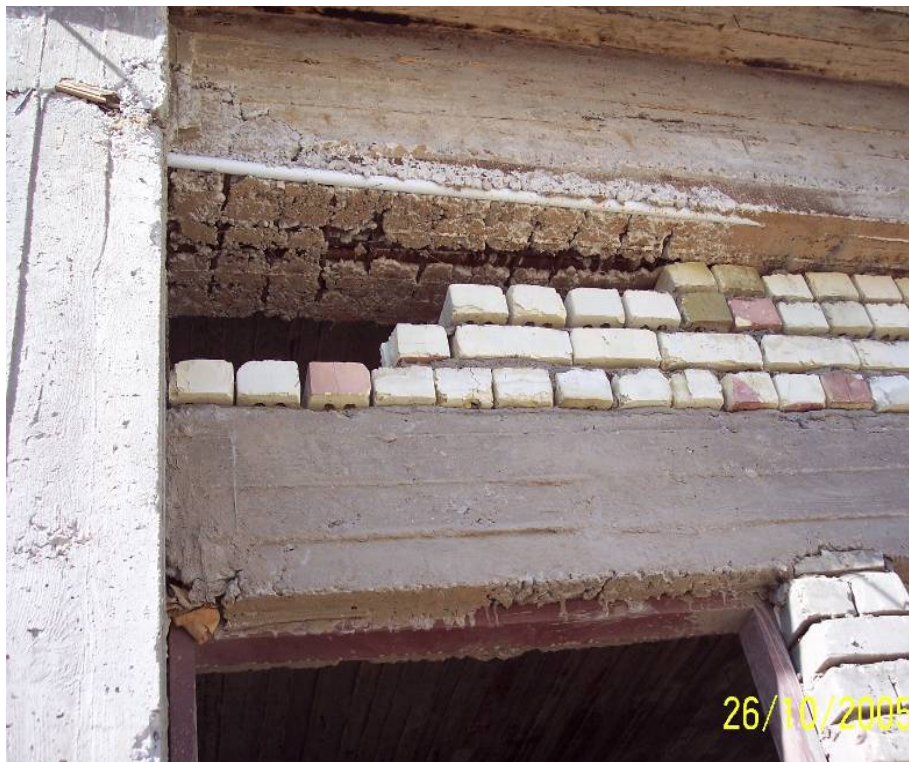
**Site Photo 49. Concrete segregation and electrical conduit exposure**  
(Photo courtesy of the USACE)

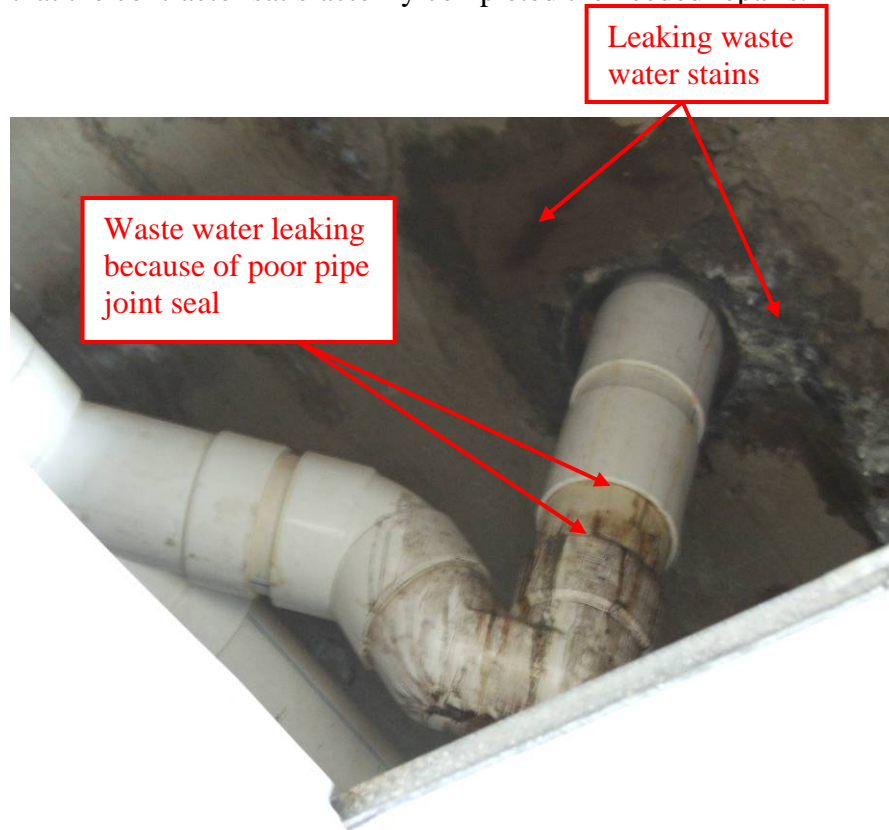
**Site Photo 61. November 2006 SIGIR Inspections photograph of contractor’s plumbing rework. Photo illustrates improper sealing of pipes.**

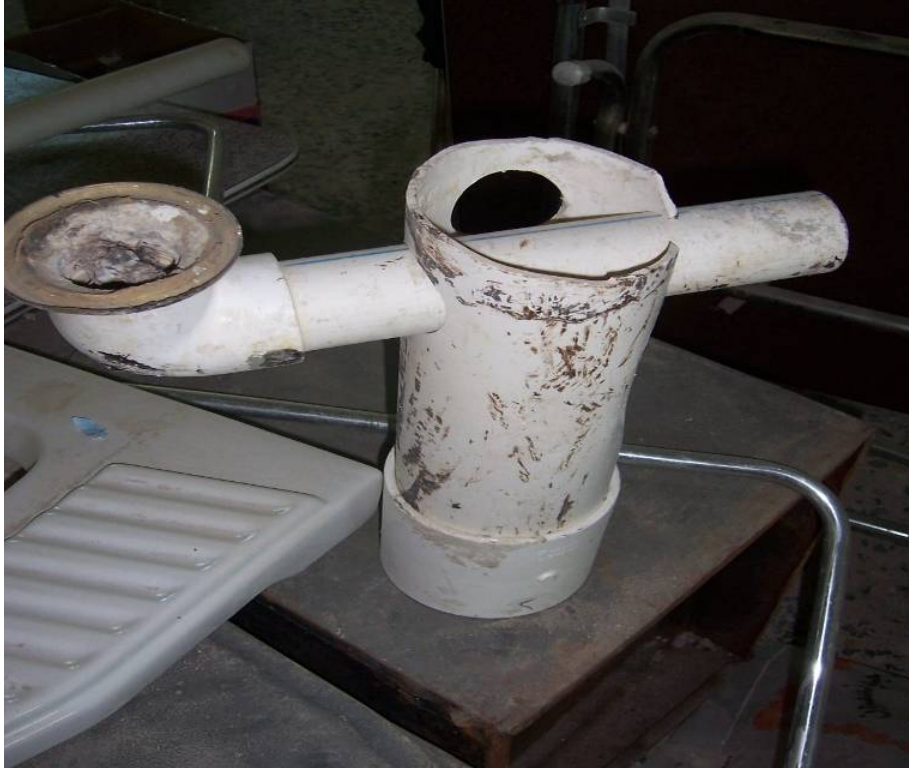
**Site Photo 62. Non-industry standard plumbing fixtures**

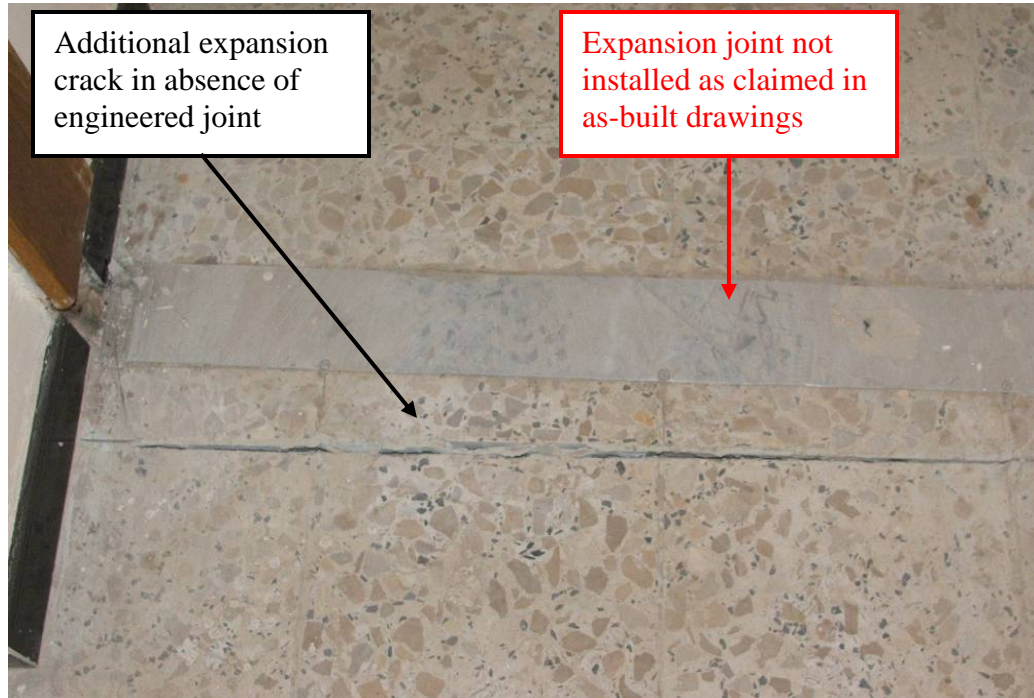
**Site Photo 65. Interior expansion crack in the instructors' barracks**

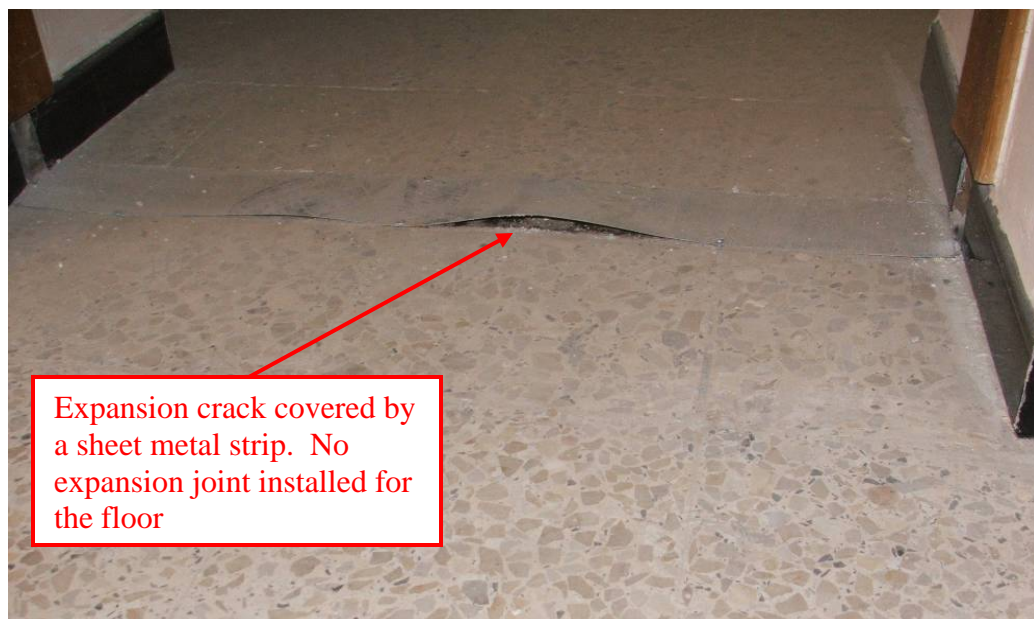
**Site Photo 66. Interior expansion crack in instructors' barracks**

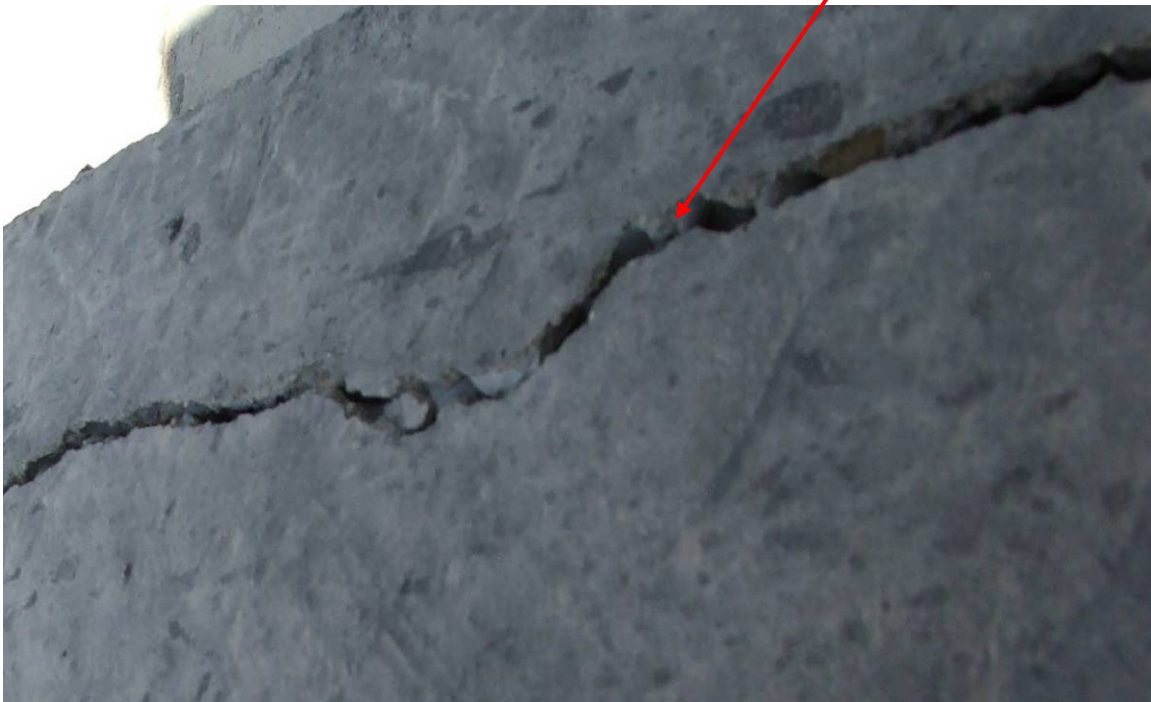
**Site Photo 68. Enlarged view of Site Photo 67.**

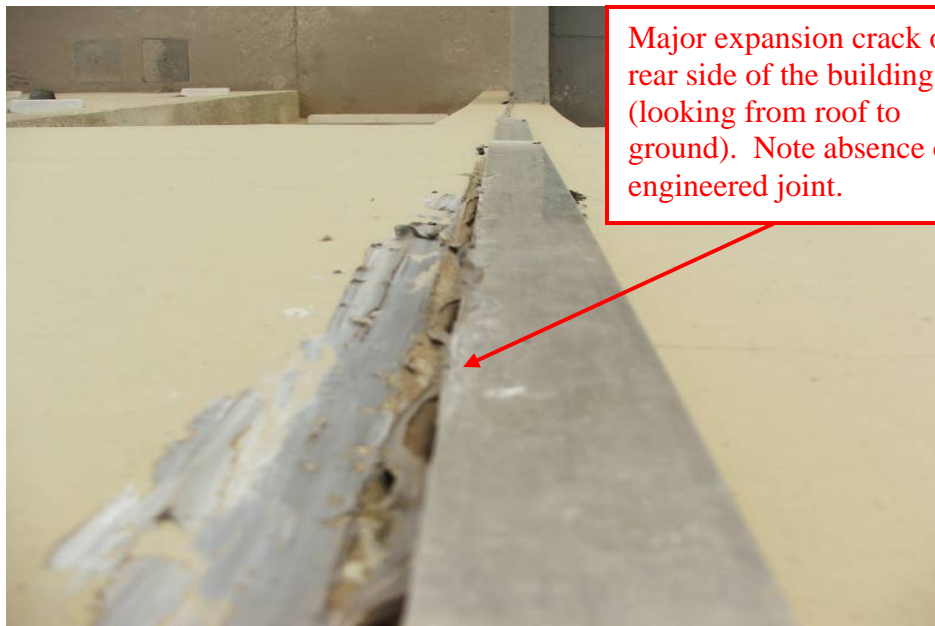
Major expansion crack on rear side of the building (looking from roof to ground). Note absence of engineered joint.

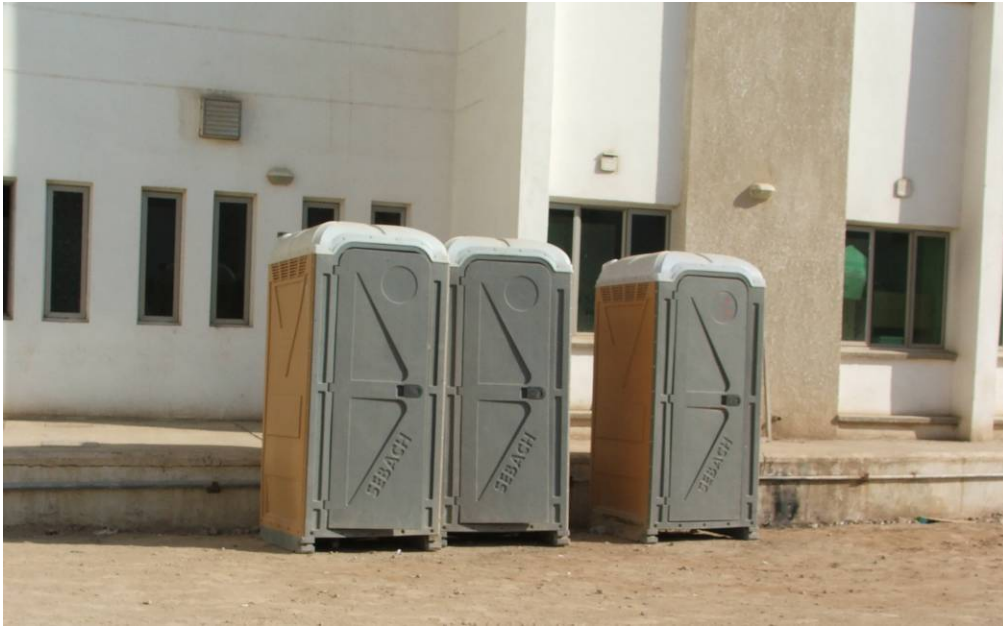
On at least two of our site visits, the BPC campus was shut down due to water system problems, causing the cadets to lose valuable classroom instruction time. In fact, on our last visit, 8 December 2006, we observed port-a-pots outside the cadet barracks. BPC representatives stated this was necessary because the water was turned off due to problems with the system and plumbing issues within the cadet barracks (Site Photo 72). During this time frame, the BPC was shut down for several days, again causing the cadets to lose valuable instruction time.

**Site Photo 72. Port-a-pots located outside the cadet barracks in December 2006**

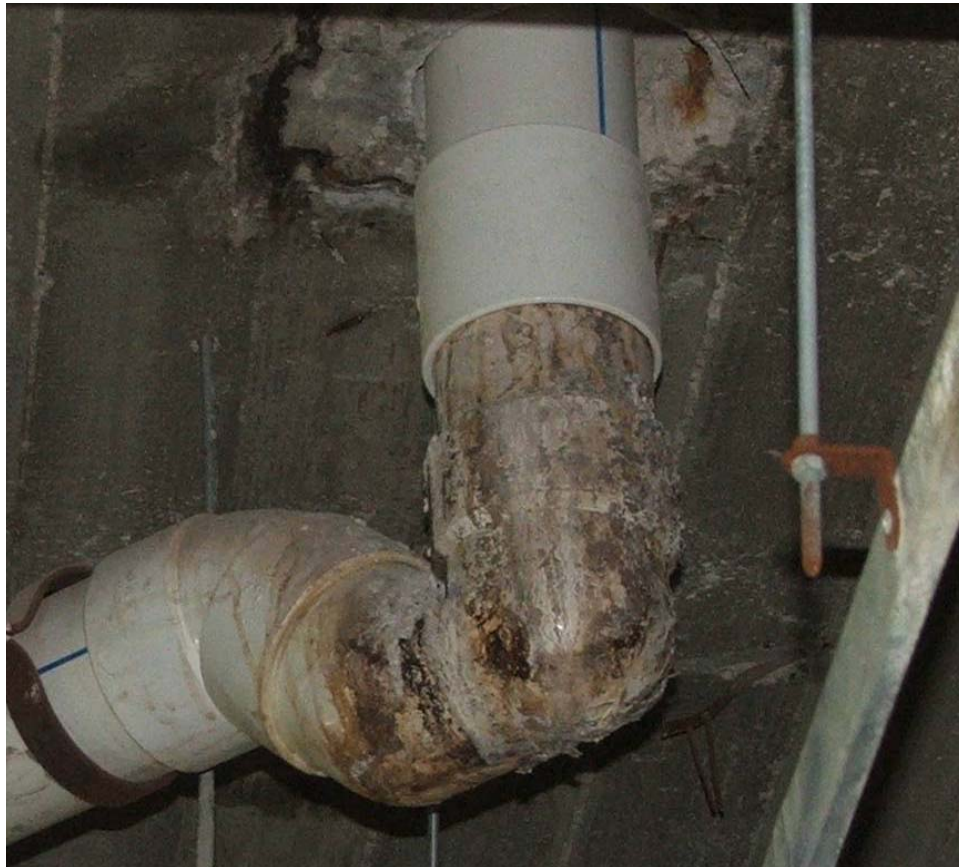
**Site Photo 73. Significant plumbing leaks resulting from poorly sealed pipes**

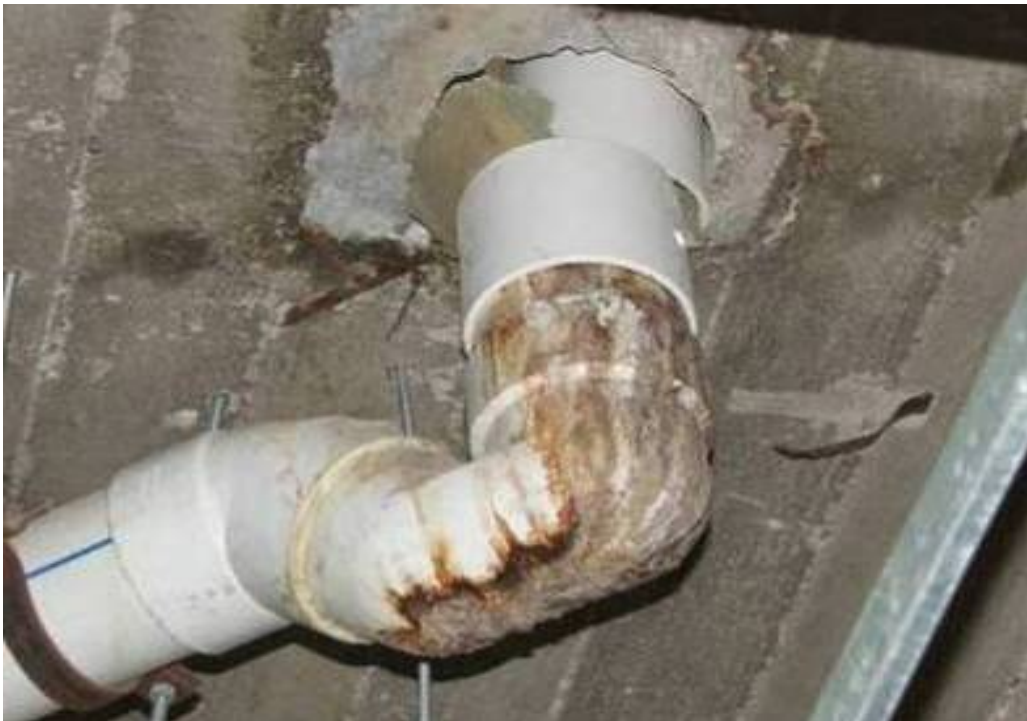
**Site Photo 74. Significant plumbing leaks resulting from poorly sealed pipes**

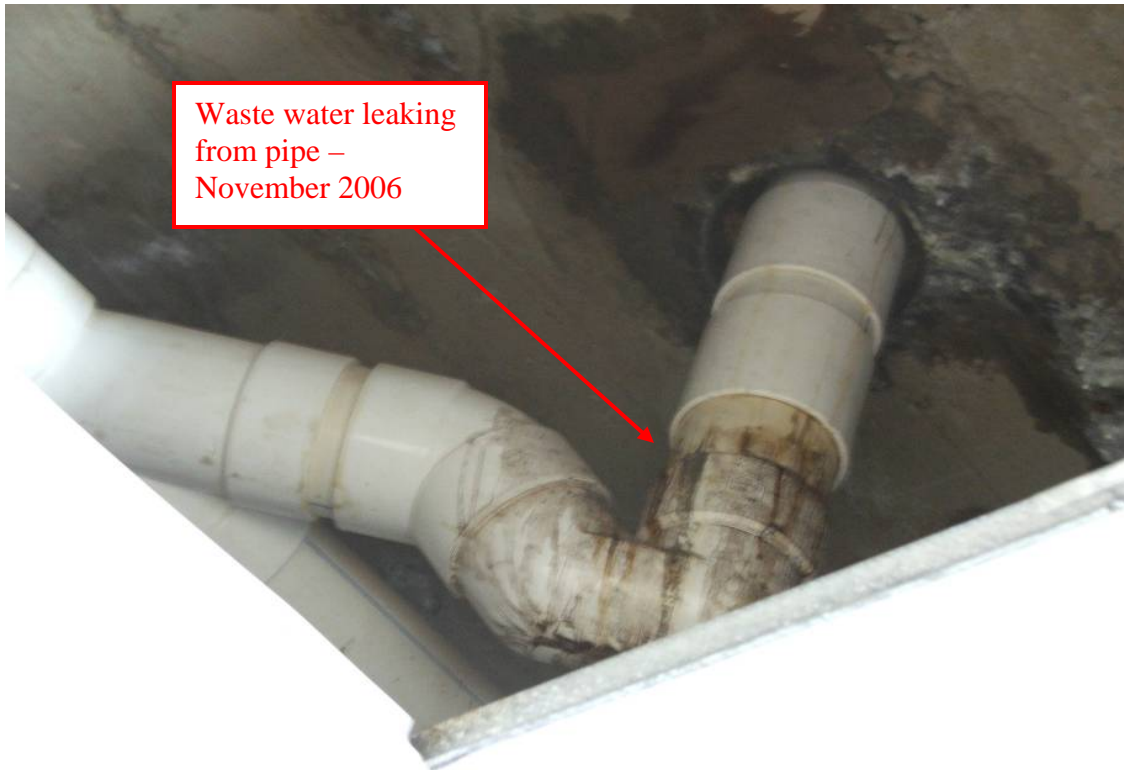
**Site Photo 75. Effect of leaking waste water on plumbing pipes**
